**CAROLINA POWER & LIGHT
MAYO ELECTRIC GENERATING PLANT**

**MAYO CREEK DAM
ASH POND DAM
PERSON COUNTY, NORTH CAROLINA**

**FIVE-YEAR INDEPENDENT CONSULTANT INSPECTION
AS REQUIRED BY
NORTH CAROLINA UTILITIES COMMISSION**

December 22, 1999

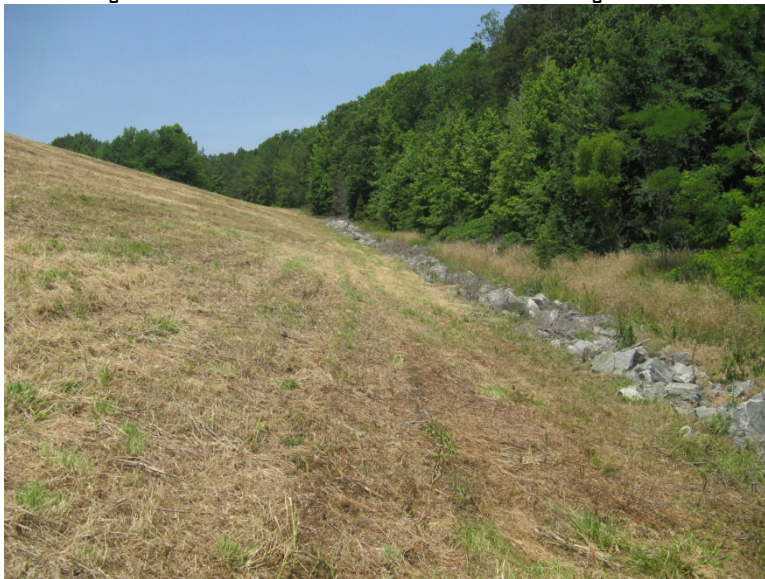
Photo 7: Internal Drain Outlet, Toe, Photo: 019, 6/3/09
